LABORATORY MEASUREMENT OF IMPACT SOUND INSULATION OF A FLOORING SYSTEM (According to ISO 10140-3)

**LABORATORY
MEASUREMENT OF
IMPACT SOUND
INSULATION OF A TONGUE
AND GROOVE FLOORING
SYSTEM**

**Normalized impact sound pressure levels according to ISO 10140-3
Laboratory measurements of impact sound insulation of floors**

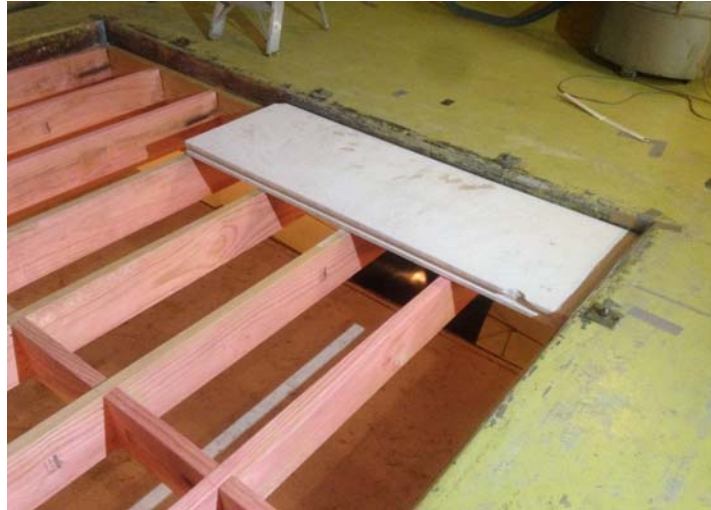
Figure 1: Installing the Rockcote panels on the timber joists

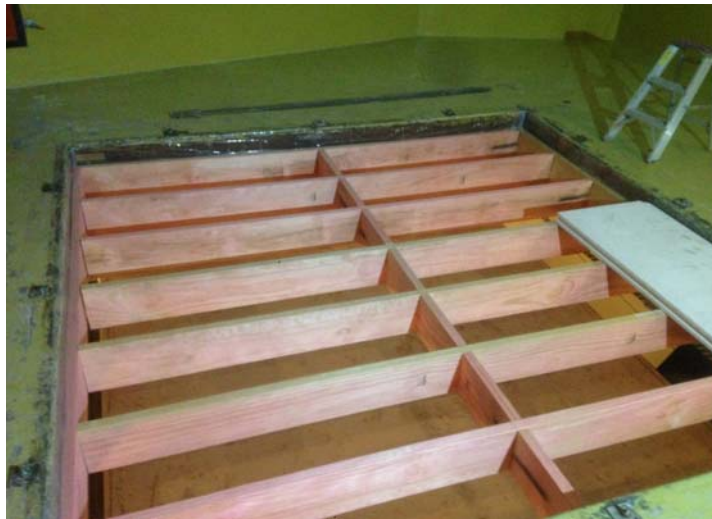
Figure 2: Floor joists framing showing the central nogs.

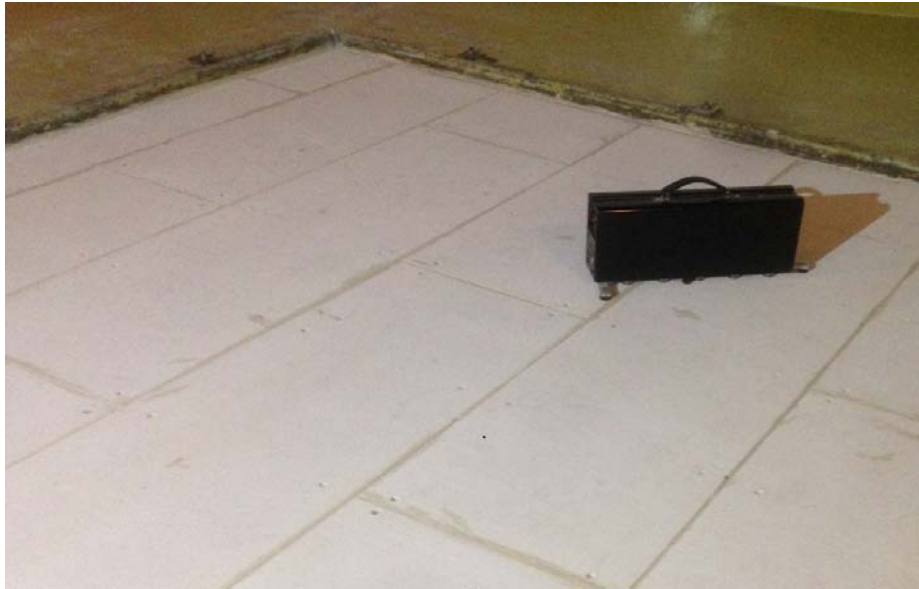
Figure 3: One of the tapping machine positions on the completed floor

The BK3204 tapping machine is placed sequentially in four different positions on the floor. The impact sound pressure level is measured in the room below the floor, using a rotating microphone, in third octave frequency bands. The impact sound pressure levels are normalized against the room absorption. The room absorption is calculated from the reverberation time and room volume. The reverberation time is measured from the decay of a steady state sound field. Corrections are applied, where necessary, for airborne sound transmission and background noise. The airborne sound transmission is determined using a loudspeaker and the microphone.

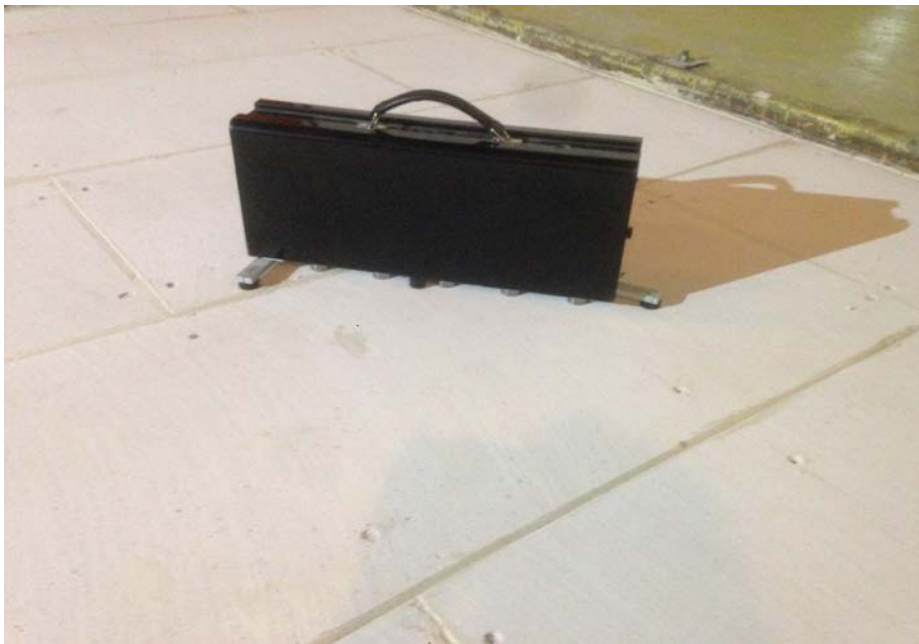
Figure 4: Tapping machine placed on panels showing screw-fixings
