# LABORATORY MEASUREMENT OF IMPACT SOUND INSULATION OF A FLOORING SYSTEM (According to ISO 10140-3)

**LABORATORY  
MEASUREMENT OF  
IMPACT SOUND  
INSULATION OF A TONGUE  
AND GROOVE FLOORING  
SYSTEM**

No. of test report: **T1608-2**

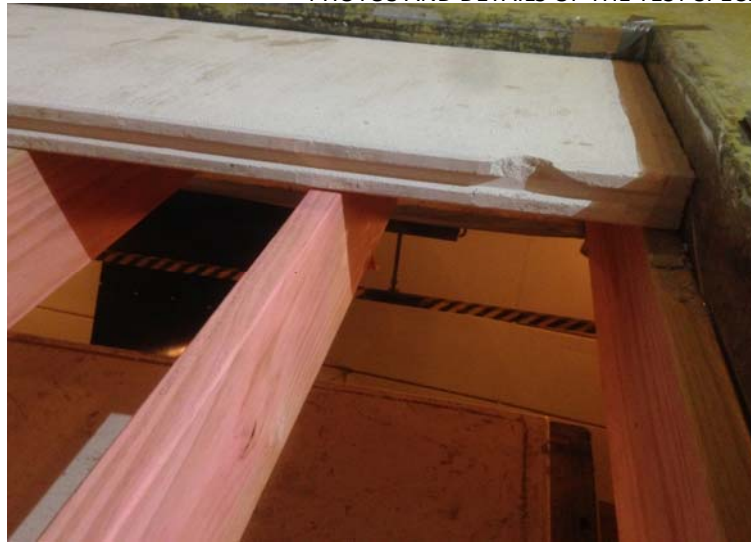
Figure 1: Rockcote panels sitting on timber joist floor structure

**Test Floor Frame:** 190mm x 45mm timber joists set at 450mm centres

**Test Floor Linings:** Source chamber side: *Rockcote Resene Integra* tongue and groove flooring panels

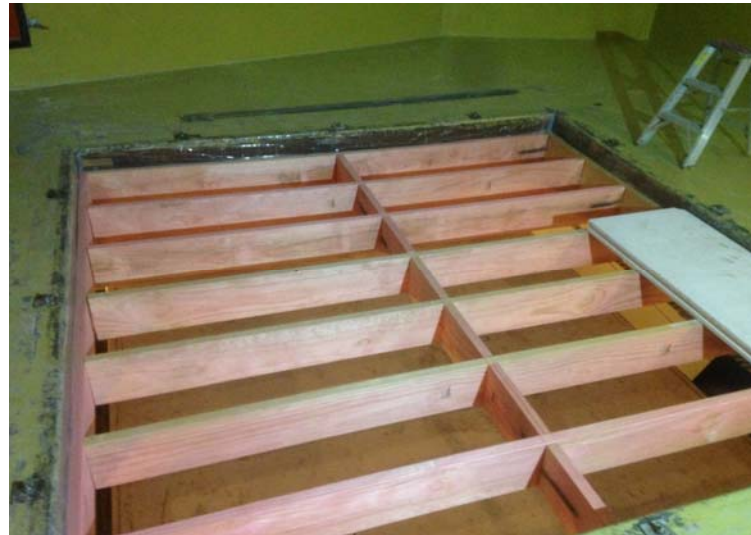
Figure 2: Floor structure installed in floor test cavity

The floor/ceiling system under test is installed in the opening between the two large reverberation chambers – chambers B and A. These chambers are vibration isolated from each other which results in a structural discontinuity at the middle of the test opening. This gap is covered over by a wooden collar, which seals the gap and provides for ease of fixing of samples. The sample is constructed by the client following the techniques normally used in practice for that type of floor/ceiling system, and is sealed into the test opening with perimeter seals of acoustic sealant.

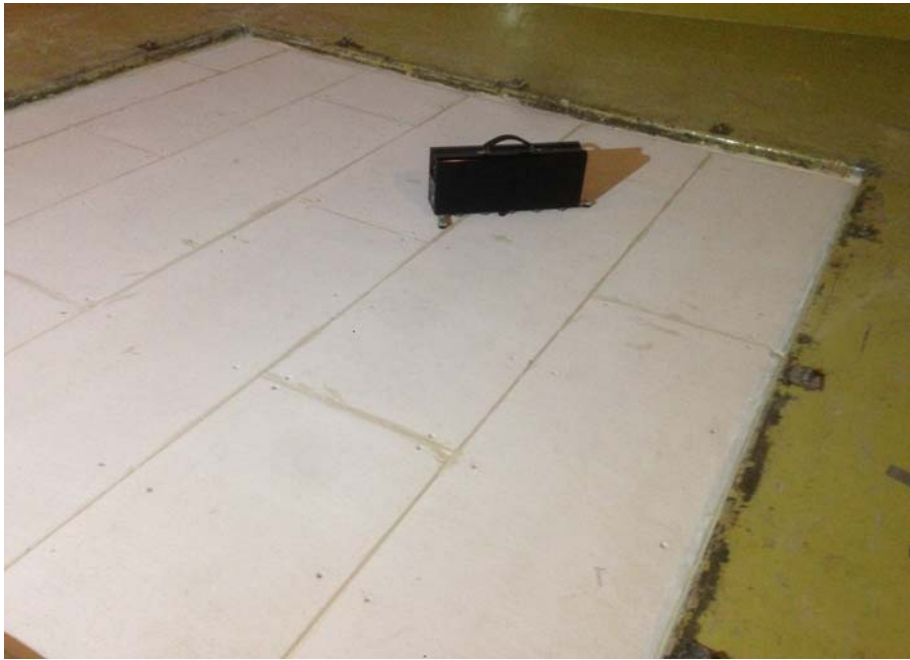
Figure 3: One of the tapping machine positions on the test floor

The BK3204 tapping machine is placed sequentially in four different positions on the floor. The impact sound pressure level is measured in the room below the floor, using a rotating microphone, in third octave frequency bands. The impact sound pressure levels are normalized against the room absorption. The room absorption is calculated from the reverberation time and room volume. The reverberation time is measured from the decay of a steady state sound field. Corrections are applied, where necessary, for airborne sound transmission and background noise. The airborne sound transmission is determined using a loudspeaker and the microphone.

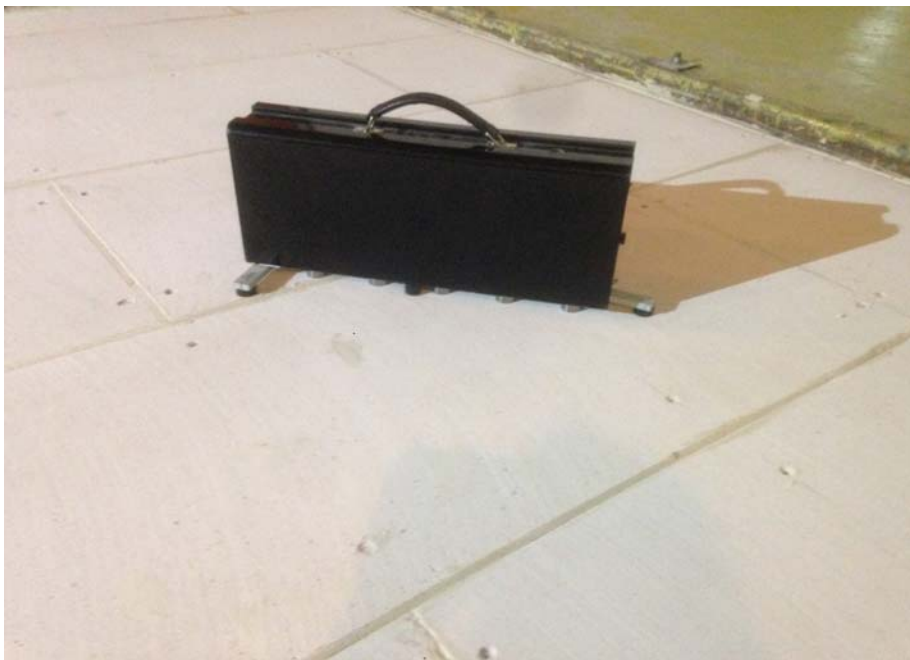
Figure 4: Tapping machine placed on floor panels

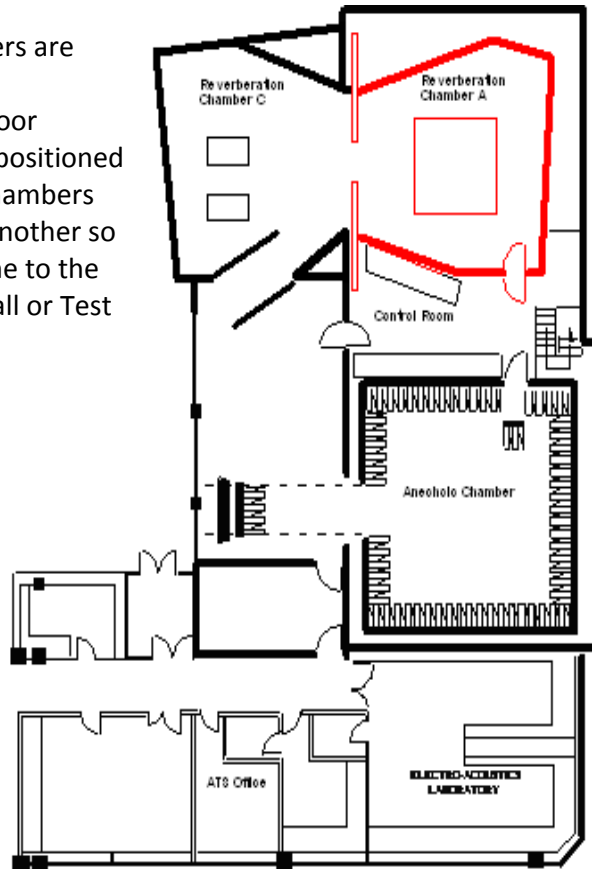
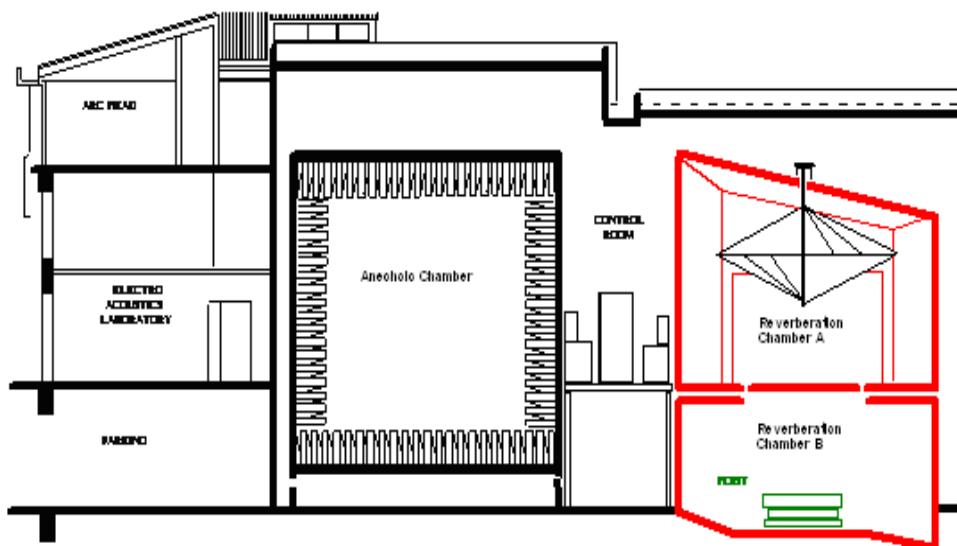
VOLUME (m <sup>3</sup> )	SURFACE AREA (m <sup>2</sup> )
Chamber A	202 ± 3	203.6 ± 0.9
Chamber B	153 ± 2	173 ± 1
Chamber C	209 ± 4	214 ± 0.9

The three Reverberation Chambers are linked by heavy steel doors and a removable Standard Industrial Floor Section which is removed and repositioned by a hydraulic hoist. The three chambers are vibration isolated from one another so that sound can only pass from one to the other via the intervening Test Wall or Test Floor/Ceiling Section
