LABORATORY MEASUREMENT OF IMPACT SOUND INSULATION OF A FLOORING SYSTEM (According to ISO 10140-3)

**LABORATORY
MEASUREMENT OF
IMPACT SOUND
INSULATION OF A TONGUE
AND GROOVE FLOORING
SYSTEM**

No. of test report: T1608-4

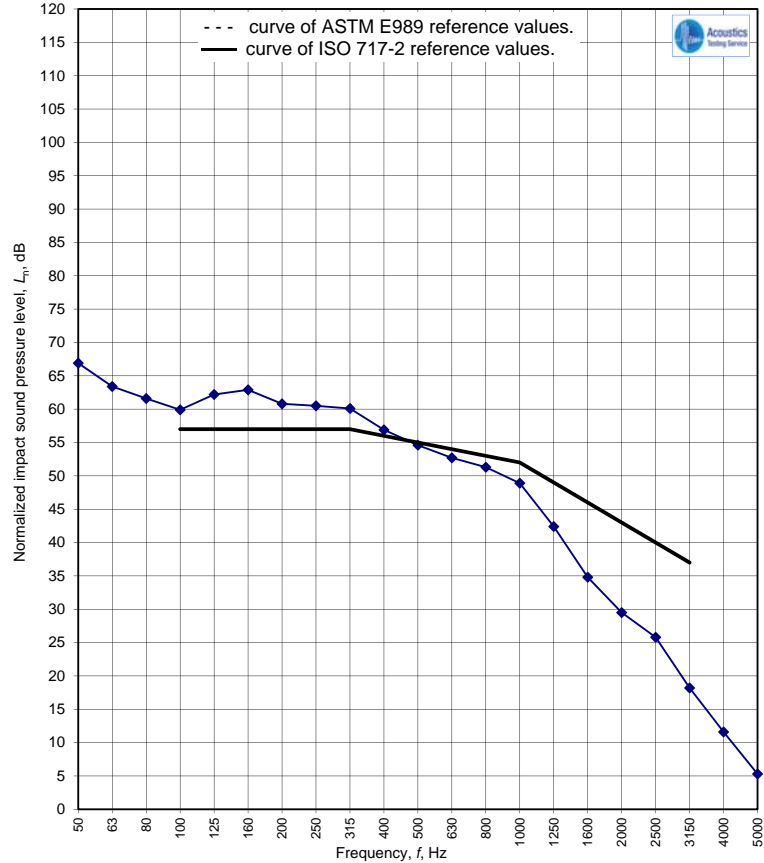
Frequency <i>f</i> Hz	<i>R</i> One-third octave dB
50	66.9
63	63.4
80	61.6
100	59.9
125	62.2
160	62.9
200	60.8
250	60.5
315	60.1
400	56.9
500	54.6
630	52.7
800	51.3
1000	48.9
1250	42.4
1600	34.8
2000	29.5
2500	25.8
3150	18.2
4000	11.6
5000	< 5.3

Rating according to ISO 717-2: $L_{n,w}(C_1) = 55 (0) \text{ dB}$ $C_{1,50-2500} = 3 \text{ dB}$
Rating according to ASTM E989: Impact Insulation Class = 55 dB
Evaluation based on laboratory measurement results obtained by an engineering method.

The third octave band normalized impact sound pressure levels L_n are presented in both table and graph formats. Sometimes a highly reflective test sample means that the lower frequency normalized impact sound pressure levels cannot be reliably measured; this is indicated by #N/A in the table of results. Additionally, sometimes the airborne transmission of sound through the floor or loud background noise affects the measurements resulting in only an upper threshold being found; this is indicated by a < sign preceding the tabulated results.

Single figure ratings are also presented. The weighted normalized impact sound pressure level $L_{n,w}$, determined according to ISO 717-2, is presented along with a spectrum adaptation term C_1 . $L_{n,w}$ is determined by fitting a reference curve to the third octave band normalized impact sound pressure levels L_n from 100Hz to 3150Hz, and gives a single figure determination of the sound levels which are transmitted through the floor from impacts (higher is worse). The spectrum adaptation term C_1 is used to suggest the presence of high level peaks in the results over the frequency range 100Hz to 2500Hz, and may be added to $L_{n,w}$. For massive floors with effective coverings C_1 will be about zero, for light timber floors C_1 will be slightly positive, and for concrete floors with less effective covering C_1 will range from -15 dB to 0dB. Another spectrum adaptation term $C_{1,50-2500}$, which covers the frequency range from 50Hz to 2500Hz, may also be presented if the low frequency levels are available.

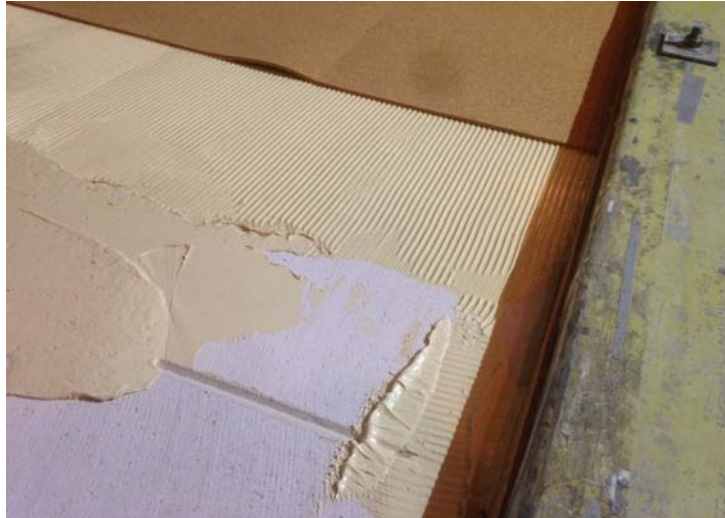
Figure 1: Cork being adhered to the Rockcote flooring panels

Test Floor Linings: *Source chamber side:* 15mm Oak timber flooring loose laid on 6mm cork adhered to *Rockcote Resene Integra* tongue and groove flooring panels

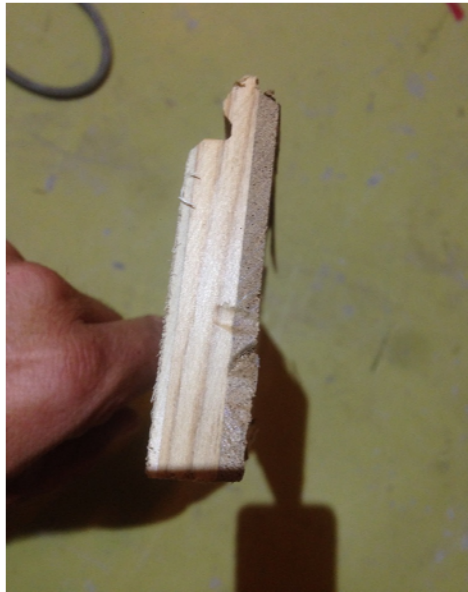
Figure 2: Cross section of oak flooring

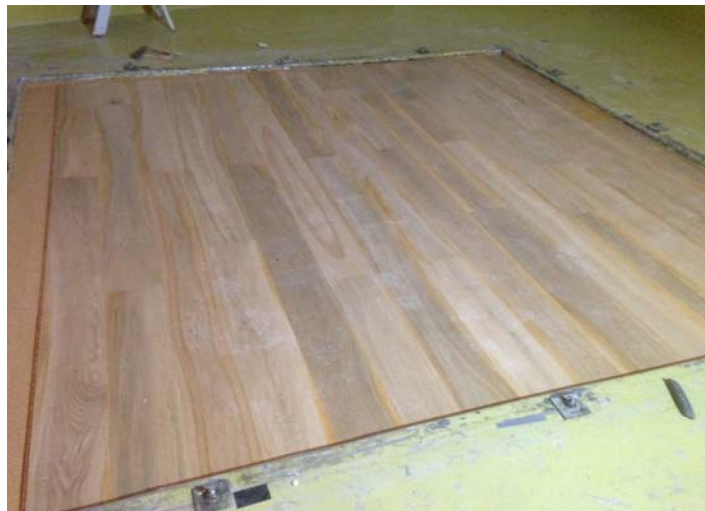
Figure 4: Finished floor with oak flooring panels

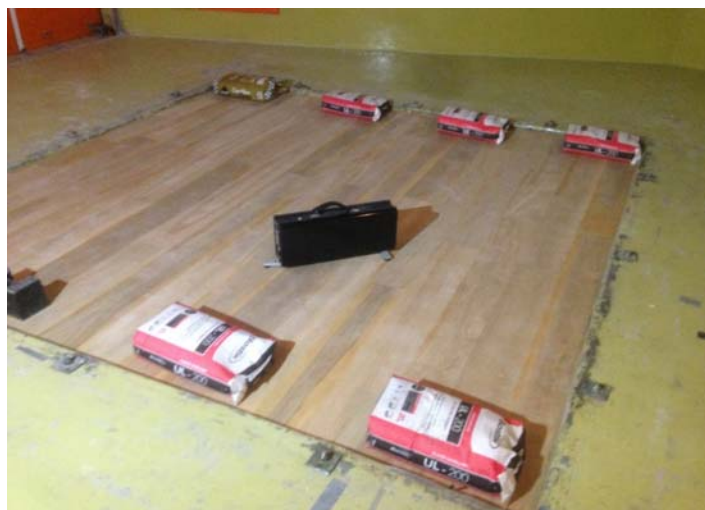
Figure 5: Tapping machine positioned on the test floor

The BK3204 tapping machine is placed sequentially in four different positions on the floor. The impact sound pressure level is measured in the room below the floor, using a rotating microphone, in third octave frequency bands. The impact sound pressure levels are normalized against the room absorption. The room absorption is calculated from the reverberation time and room volume. The reverberation time is measured from the decay of a steady state sound field. Corrections are applied, where necessary, for airborne sound transmission and background noise. The airborne sound transmission is determined using a loudspeaker and the microphone.

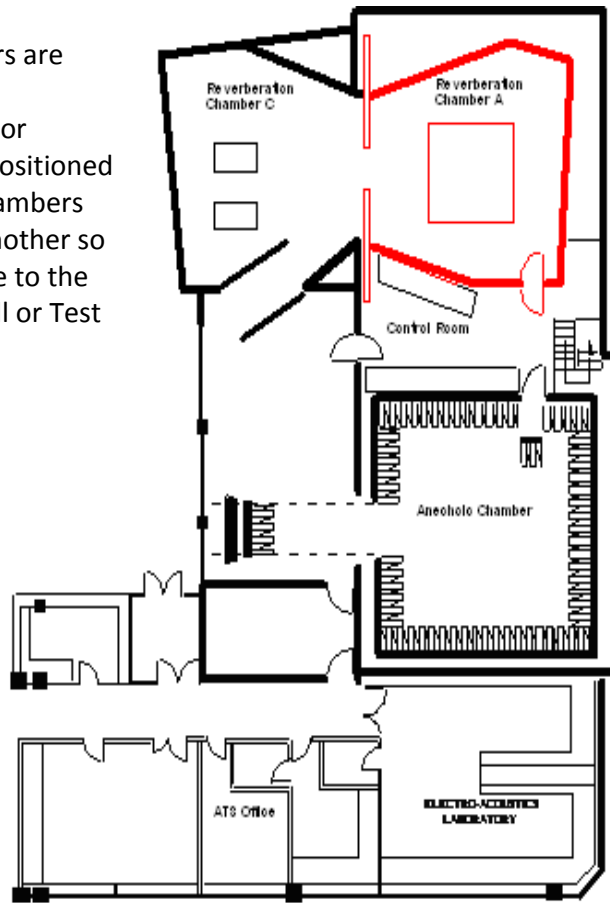
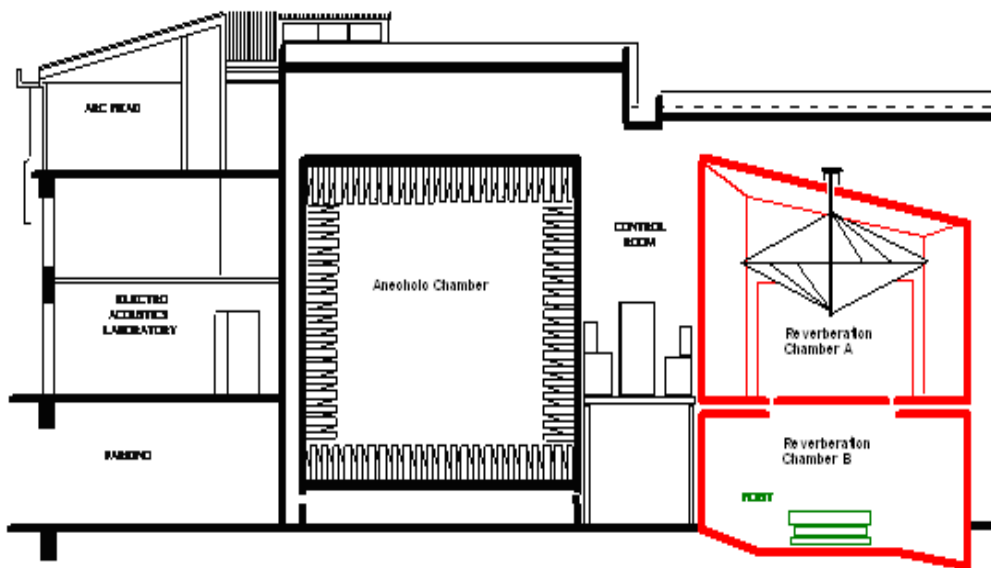
The three Reverberation Chambers are linked by heavy steel doors and a removable Standard Industrial Floor Section which is removed and repositioned by a hydraulic hoist. The three chambers are vibration isolated from one another so that sound can only pass from one to the other via the intervening Test Wall or Test Floor/Ceiling Section

There are three large interconnected reverberation chambers at the Acoustics Research Centre, two at ground level (Chambers C and A) and the third (Chamber B) below A.

All three reverberation chambers may be described as hexagonal prisms; each has 6 vertical sided walls, perpendicular to the floor. The roofs of chamber A and C are plane, but inclined at 12 degrees from horizontal. Chamber B has a plane, horizontal roof which is the floor of chamber A above it. The floor of chamber B is also horizontal, but has two angled sections at its North West and south east ends. The centre section is horizontal because a floor jack is installed there. The floor jack may be raised hydraulically to the ceiling of chamber B, the centre of which consists of a floor plug between the two chambers. This plug may be disconnected from chamber A and lowered down into chamber B, leaving a 3.2m x 3.2 m opening between the two chambers. This allows for the measurement of airborne and impact insulation of floor and roof elements.
